Intel[®] Mobile Celeron[™] Processor at 466 MHz, 433 MHz, 400 MHz, 366 MHz, 333 MHz, 300 MHz, and 266 MHz Specification Update

Release Date: June 2000

Order Number: 244444-015

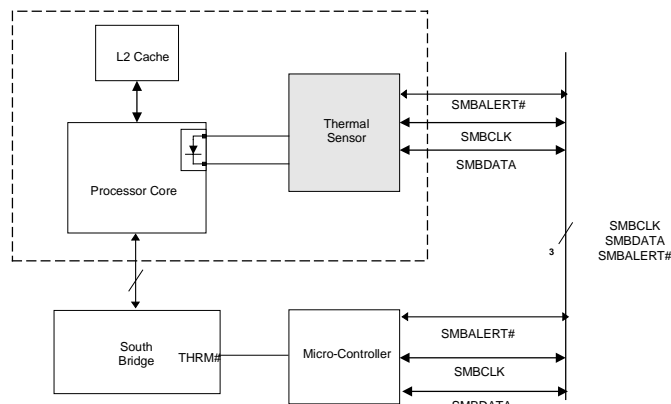
Figure 1. An Example of Microcontroller Driven Thermal Management

H29. Thermal Sensor May Assert SMBALERT# Incorrectly

Problem: The Intel Celeron Processor Mobile Module has a thermal sensor that monitors the processor core's temperature. Please note that desktop systems could have a similar thermal device. The thermal sensor asserts SMBALERT# if the processor temperature exceeds the temperature limits set in the Alarm Threshold Registers (T_{HIGH} , T_{LOW}). It also sets the corresponding Status Register bits to identify the cause of the interrupt. Figure 1 gives one example of the how the SMBALERT# signal could be used in a system.

Implication: There is no system impact from this erratum if temperature polling is used for processor thermal management. If the SMBALERT# interrupt is employed to manage processor thermal sensing, then servicing the false interrupt may result in premature system action depending on the software and hardware implementations used. The rate of the false interrupts is less than the auto-convert rate of the thermal sensor.

Workaround: Three different (mutually exclusive) workarounds are possible:

1. Before servicing an interrupt from the thermal sensor, read and compare the processor thermal reading with the threshold limits (T_{HIGH} or T_{LOW}). Figures 2 and 3 provide basic flowcharts for the implementation of this workaround in an interrupt driven system.
2. If the firmware implemented polls the Status Register only, then before taking any action, re-read the temperature register and do a comparison with the alarm threshold limits (T_{HIGH} or T_{LOW}) to determine if the value is actually still within the temperature window.
3. Use a temperature polling scheme to monitor the processor temperature.

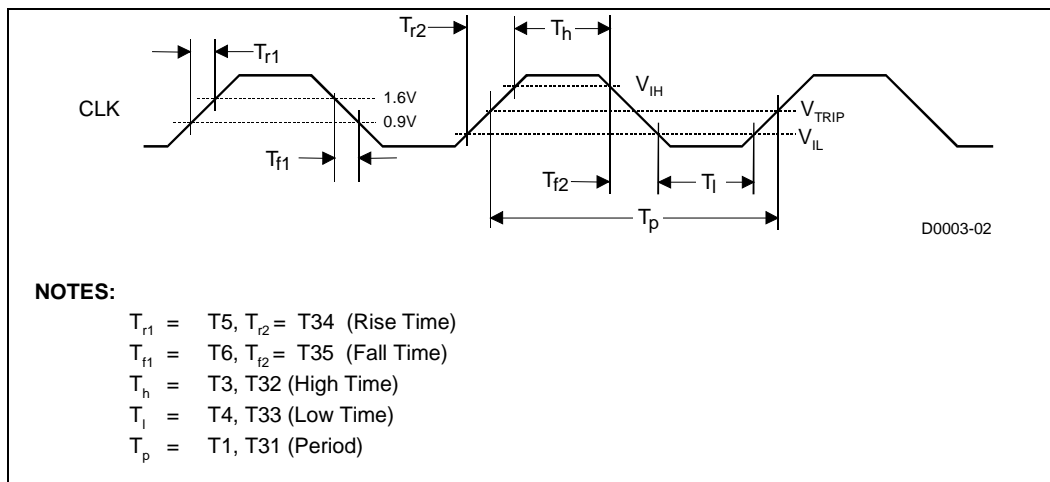
Figure 3.3 Generic Clock Waveform

H11. Generic Clock Waveform Figure

Figure 3.3 in the *Intel® Mobile Celeron™ Processor in μPGA1 and BGA1 Packages at 366 MHz, 333 MHz, 300 MHz, and 266 MHz* datasheet (Order Number 245112-003) has been updated. The following figure is to replace the one in the above document.
